Seawalls on Atolls: Lessons for Us All

Abstract

Keywords: Atolls, Seawalls, Capability -Building, Appropriate Technology

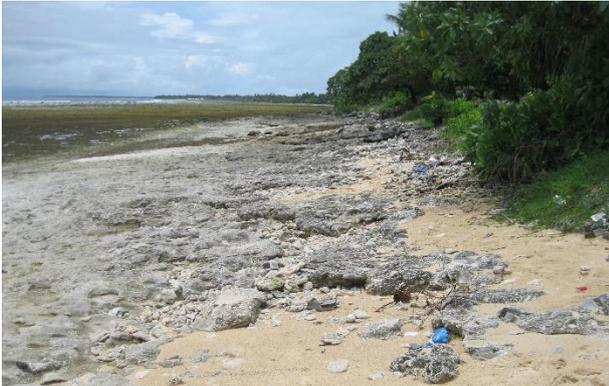
Figure 1 Typical hardened coastline: Reef flat, sand, cayrock, strand & berm. Note break up of cayrock. (Note: all photos by the Author except where attribution is given)

Figure 1 below shows a typical cay shoreline comprising the reef flat, a drift of sand or overlying a sloping rampart of beachrock, or horizons of cayrock, with a thin strand of carbonaceous sand, rising up to the berm of sand or soil or coral rubble.

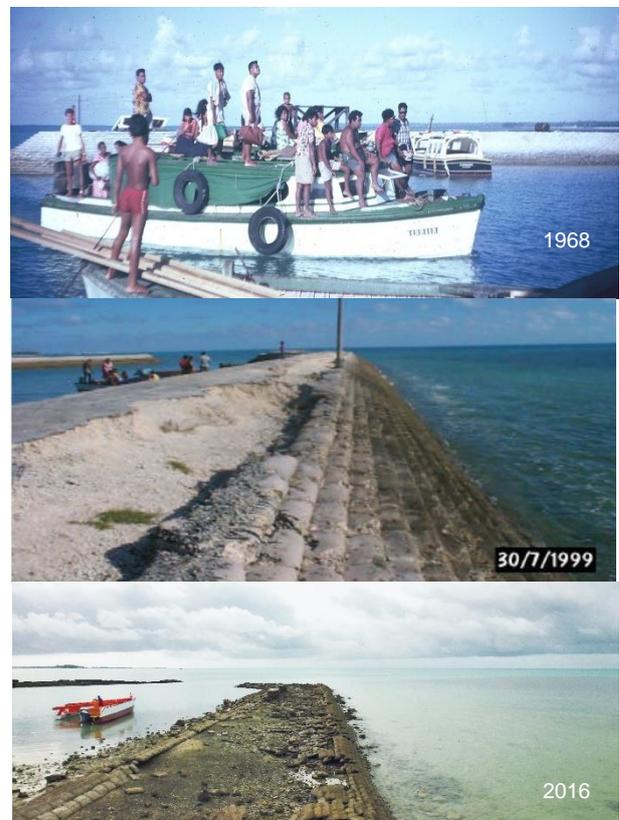
Figure 2 Bairiki Breakwater, South Tarawa lagoon. (Sources: N Pasley, SOPAC, Author)). It survived for over 30 years before lack of maintenance took its toll.

Figure 2 above shows Bairiki Breakwater, a prime example of good bagwork and poor maintenance. Built prior to 1968, the general profile was in relatively good order until the end of the century. The 1999 photo shows the initiation of damage to the crest.

With no maintenance or repairs, each successive overtopping event led to the continuing reduction of the breakwater. This sequence shows many years good service of the structure, the continued integrity of the bags and the eventual failure of the breakwater. It is estimated that waves over 1m and up to 1.6m will have occurred at this site [10].

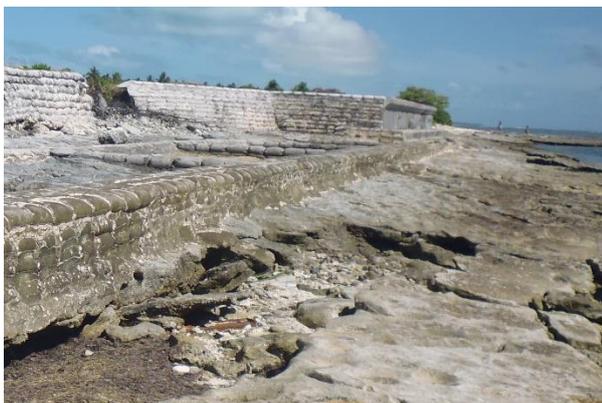
Figure 3 The East seawalls in 2016, protecting the runway from the ocean. Note the foundation sequence of cayrock, bagwork foundations and temporary works, and seawalls, both the earlier bagwork wall and the 6 year old R.C. seawall within bagwork temporary works.

During KAP II successful use of Reinforced Concrete was made with the seawall protecting the east end of the runway [11]. This used proprietary additives to protect the reinforcement and harden the concrete. Figure 3 shows the bagwork used for the foundations, on a horizon of crumbling cayrock

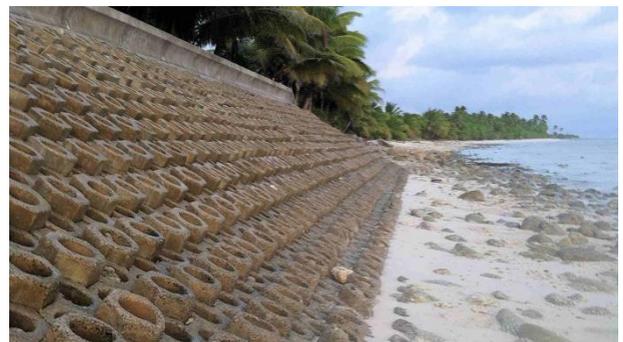
Figure 5 Seawall at Cocos Keeling. High roughness Seabees built 12 years prior to photo. Note wave wall and strand at toe [6, 7]. Simple manufacture & built by hand

Figure 4 below shows a Seabee revetment on Onotoa, made on site in 1991 using local sand and aggregate [4] and Figure 5 shows a hand-placed Seabee seawall at Cocos Keeling, built in 2001 [7, 8]: these units are royalty free have and been used at Boigu, Lord Howe and other islands, and were reported on favourably in [2].

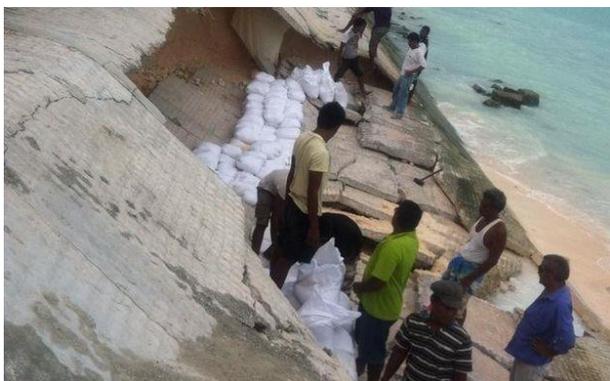
Figure 6 Dai Nippon Causeway (2017), showing the size of a hidden void exposed by sudden collapse, and continuing crack towards the crest. A hidden threat.

These are effective but rigid, inflexible, lack roughness and have no dynamically effective porosity. It is very difficult to check for hidden hollows or dissolution of the fill, so failure can be sudden and alarming, given prior notice only by arrays of cracks and small holes and seeps. Installed at several sites in Tarawa, including the Nippon causeway, the eastern seawall of Betio harbour and at the House of Parliament. All show minor shrinkage cracks and seeps. Figures 6 & 7

show the Nippon Causeway in South Tarawa, showing a sudden collapse in 2017 and recent repairs. Built in 1987 it suffered damage and overtopping caused by waves from Hurricane Pam, over 1000km away. It was rebuilt with Japanese aid in 2017-19.

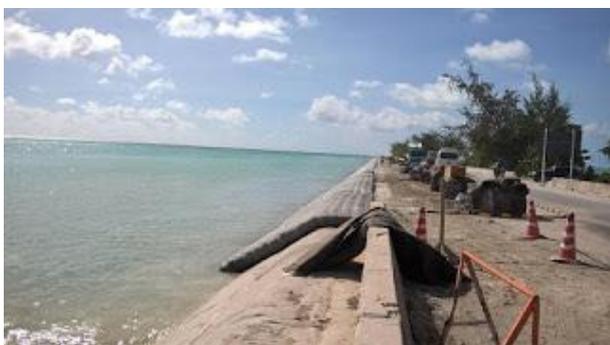
Figure 7 Dai Nippon Causeway (2018) showing repairs with 250mm thick fabriform. Note the thickness and substrate: compare with Fig 3. (photo courtesy C.Craig)

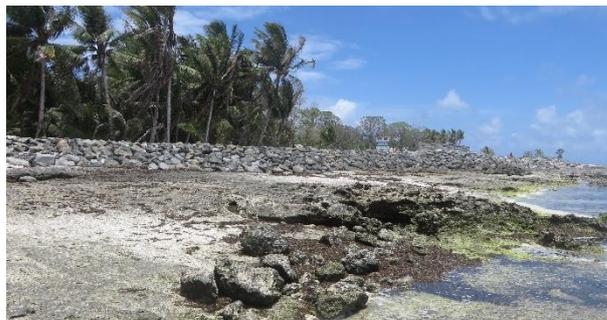
Fig 8 Rock revetment protecting new road. The foundation is above a horizon of eroding cayrock.

As part of the Kiribati Road Rehabilitation Program (KRRP), two rock seawalls were constructed at the east end of Tarawa, as shown in Figure 8. The rock was imported in containers from Fiji, some 1500 miles away. A testing load for Betio port cranes, and the highway under construction to the sites!

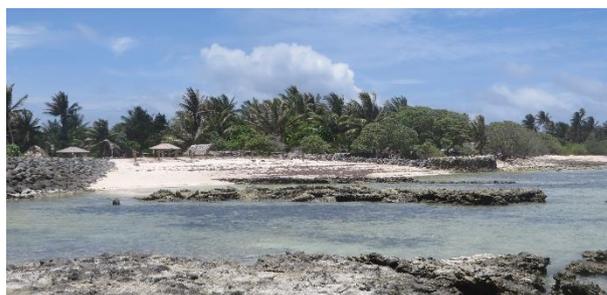
Figure 9 Beach nourishment site at north end of site 11. The tide took the sand away quite quickly on each shift

In Tarawa, the final commissioning of the dredge and aggregate grading plant now provides good supplies of carbonate sand, crushed coral aggregates and cobbles. Beach nourishment was completed as part of the KRRP (Figure 9).

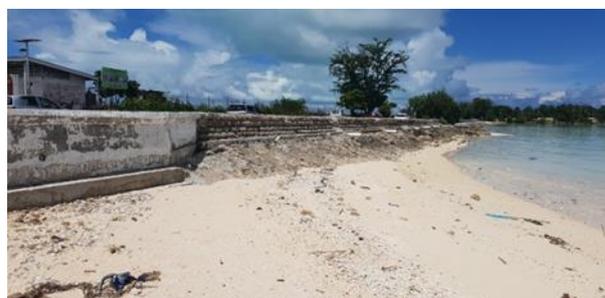
Fig 10 Site 2: Anderson Causeway seawall at Nanikai showing the new mass concrete wall founded below reef flat level beside the existing bagwork wave wall overlying the old coral wall. Amazing to consider 90% cost saving that was achieved. (Source: A Webb)

The design for Site 2 was taken back into MPWU and the problems of concrete quality and structural form addressed. With guidance and commentary, a young engineer in the MPWU, Mr. Nuati Lotolua developed a simple mass concrete design, with wave wall as shown in Figure 10. Advice was also given as to the provision of coral rubble nourishment to provide scour protection to the emergency walls, as and when funds became available...

This design used the designated mix proportions in the Kiribati Building Code, using lagoon derived aggregate and sands. This seawall was designed and built entirely by local staff and contractors, thus delivering the objective of building capability. The as-built cost was one tenth (10%) of the bid price of the lowest overseas bidder. In 2019 the same contractor finished the repairs to Betio landfill seawall, also damaged in 2015, using the novel blockwork design, as produced locally.

This was achieved at Site 2 in Tarawa (Figures 10 & 11) by changing from a standard specification requiring testing during the works, to adopting the Island Building Code, with prescribed standard mix proportions, utilising improved sources of locally produced crushed aggregates and sands. These are considered to be more than adequate for the works required.

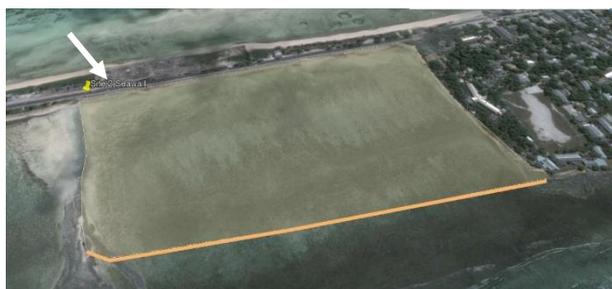
Figure 11 Site 2 shown by white arrow. This causeway wall is failing: if the 500m causeway seawall is rebuilt seaward, an area of 16 Ha could be provided for reclamation. (Google Earth)

An example of this is the Oceanside seawall of the Anderson Causeway, as shown in Figures 5 and 10 and 11. This causeway seawall is showing signs of degradation along its length and will need restoration in the near future [3]. Relocating, rather than replacing, existing seawalls may provide smaller scale distributed reclamation areas, within the capabilities of the local or regional contractors to complete, and for the aid agencies to fund.
