**MARALINGA
AND THE
DISPOSAL OF NUCLEAR WASTE**

**Former Government Representative to oversee the Maralinga Rehabilitation Project and
Member of MARTAC**

Presented to the Institution of Engineers Australia

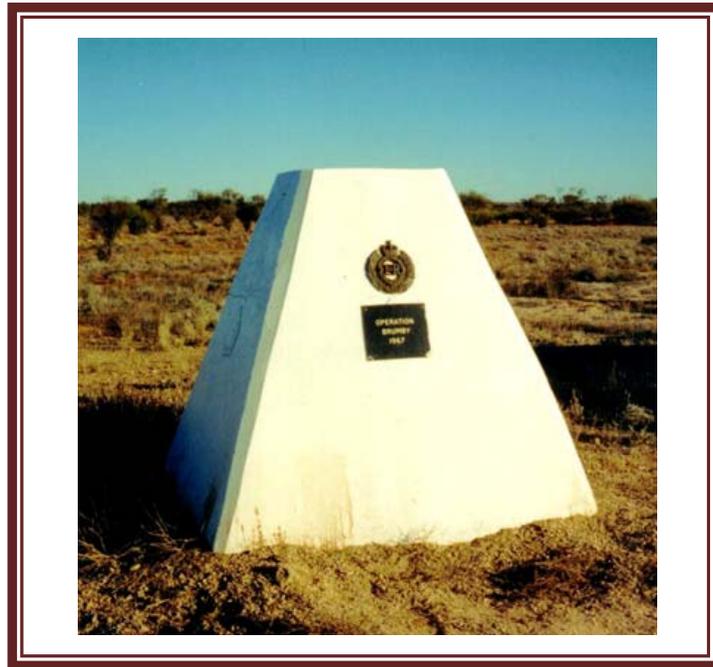
They ploughed the most contaminated areas to dilute the radioactivity in the soil. They erected fences around areas that were most contaminated, and cast concrete caps over the debris pits.

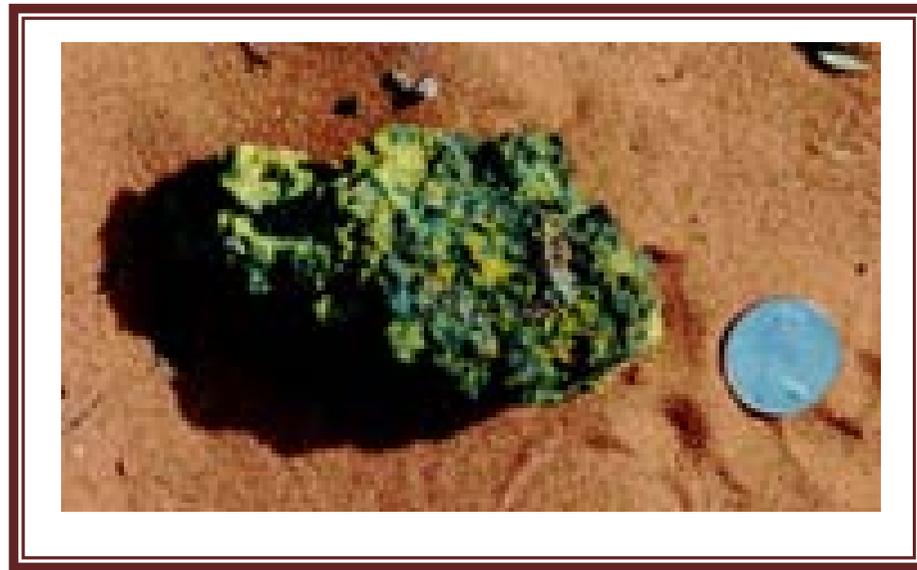
A lump of uranium metal on the surface at Kuli compared with a ten cent coin.

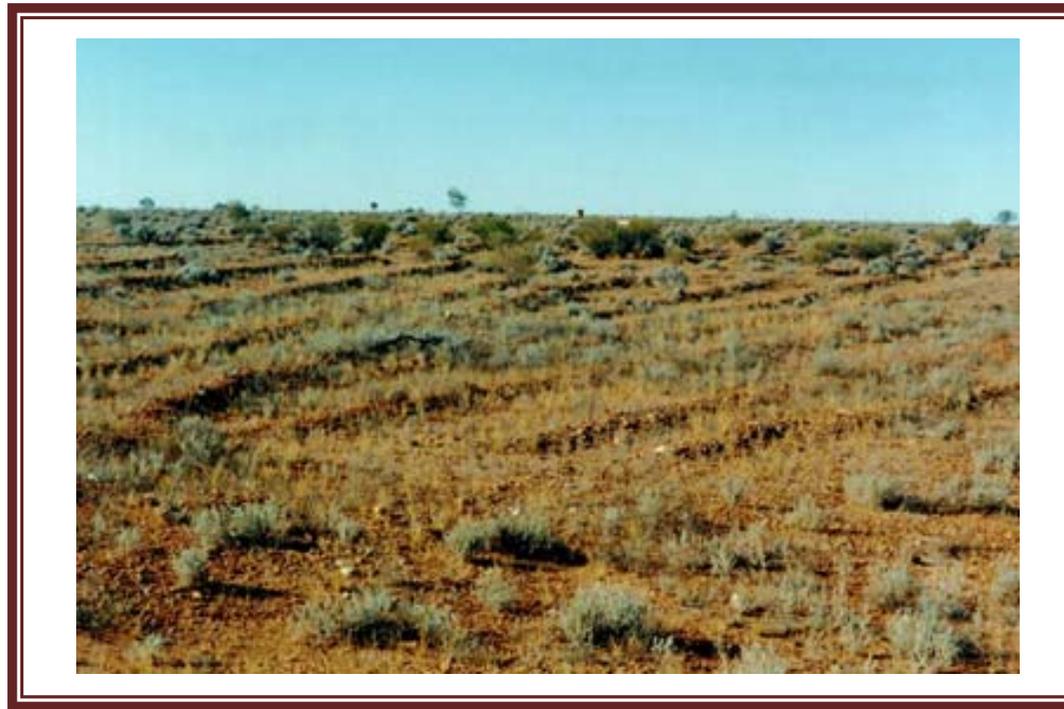
The TM site before work started – ploughed by the British to dilute radioactivity.

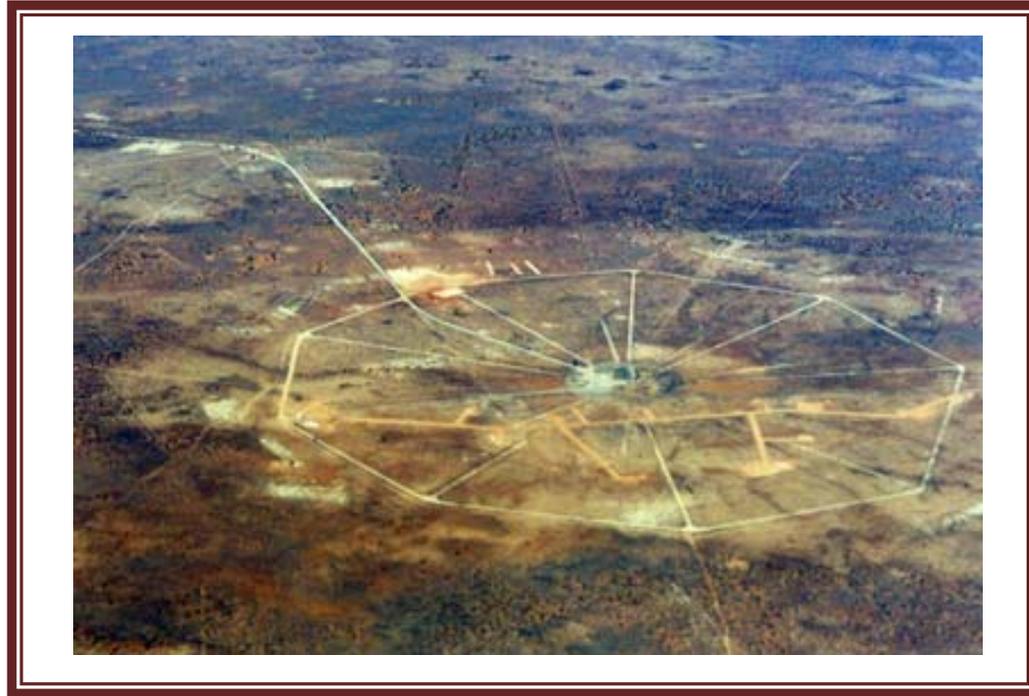
The Taranaki site viewed from the north before work started.

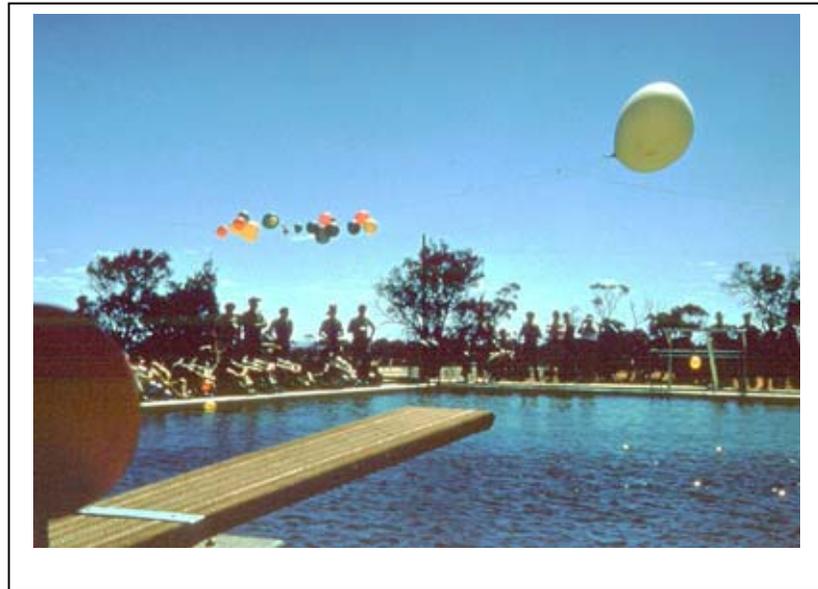
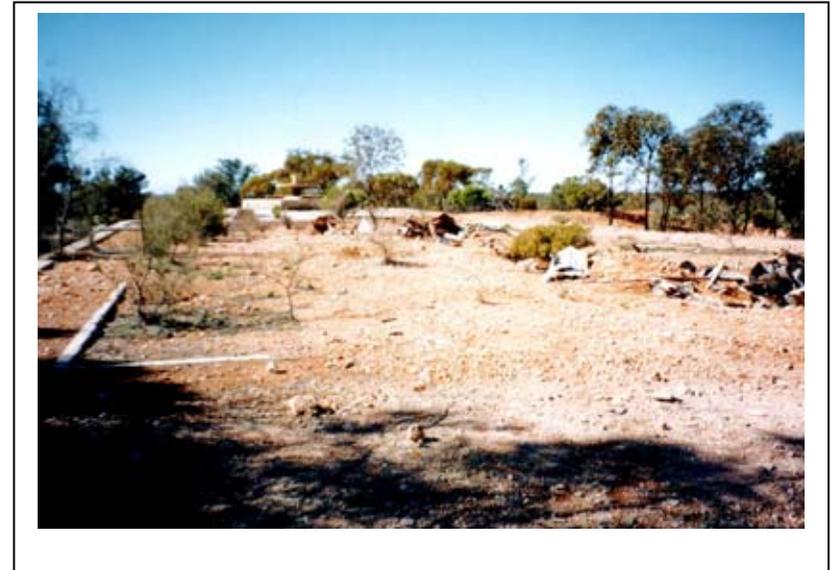
One of the ‘pits’ to be tidied was the old swimming pool in the village.

The pool during its heyday of the test era, and when the rehabilitation started.

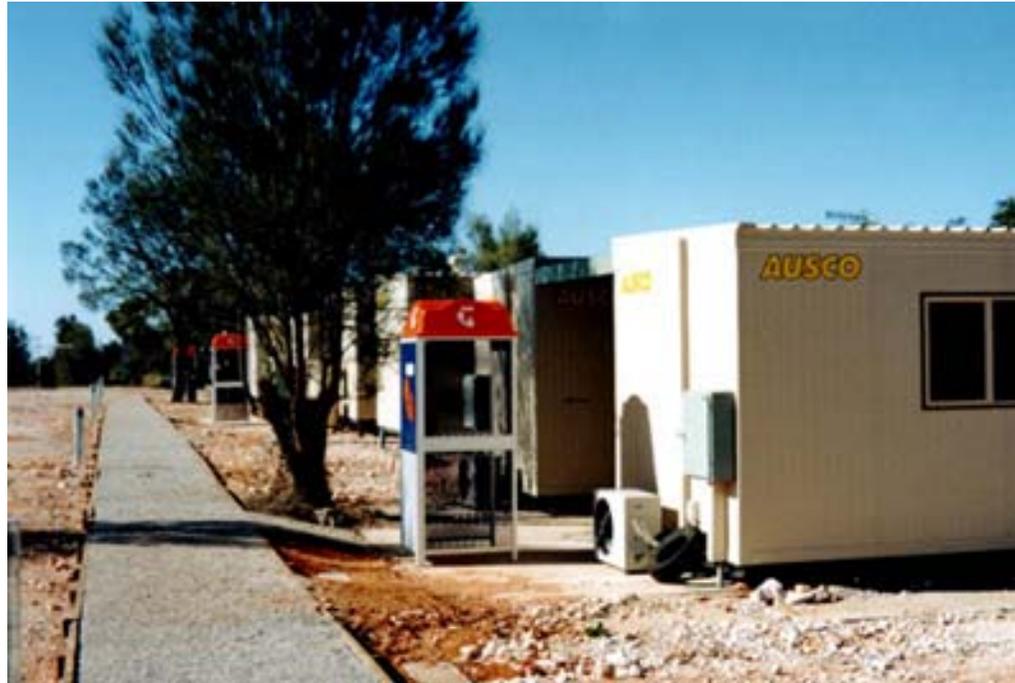
A construction camp was erected in the village, providing sleeping, washing and laundry facilities together with meal rooms, bar and some recreational facilities.

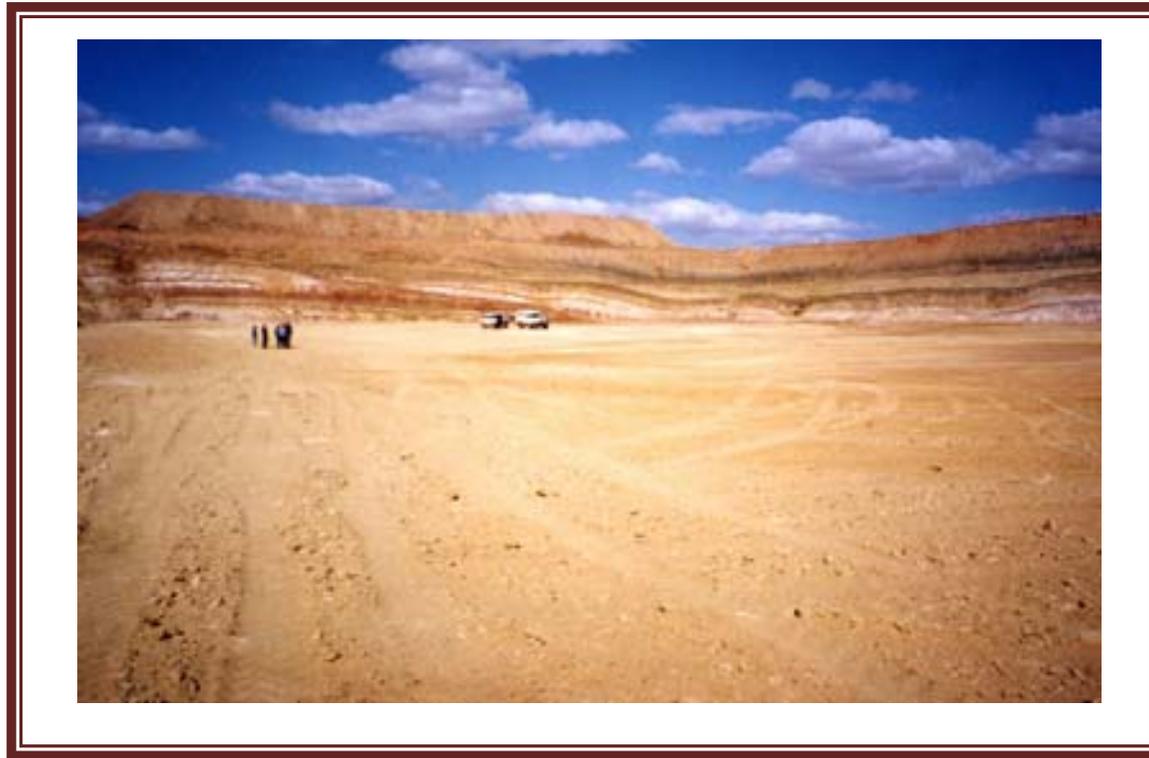
The largest burial trench was excavated at Taranaki.

It measured 205m long by 140m wide by 15m deep.

There was an entrance ramp at one end and an exit ramp at the other to allow one-way traffic through the trench.

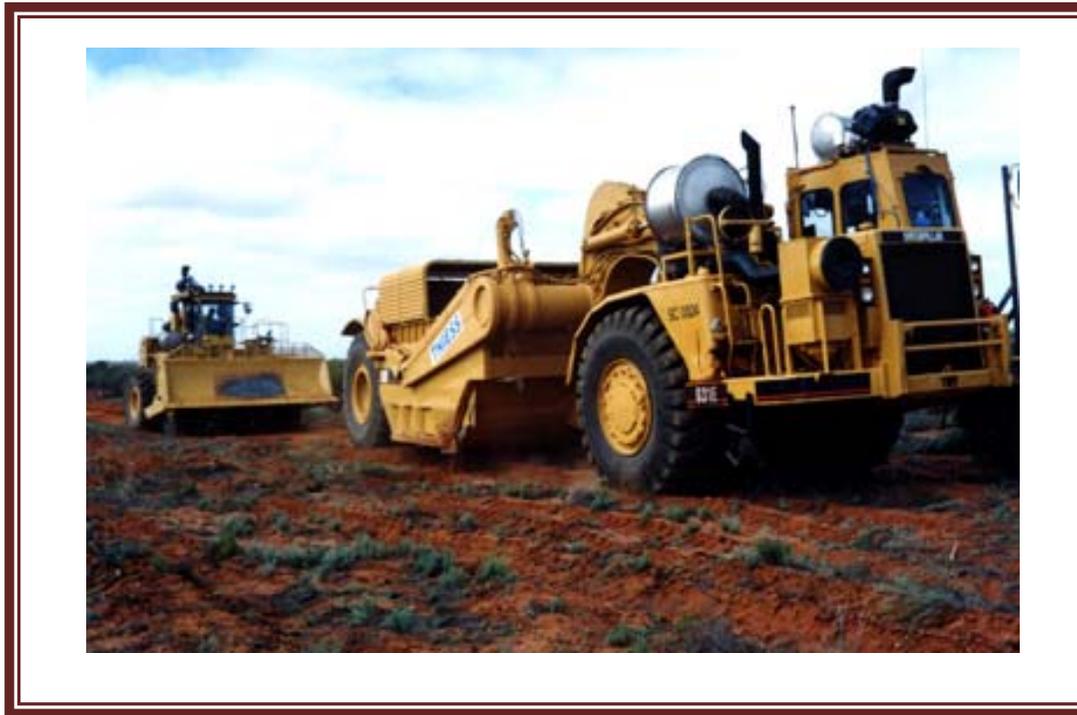
Three scrapers, assisted by a bulldozer, scraped up contaminated soil from an area designated by the Australian Radiation Laboratory (ARL).

Over a period of about 8 months they removed 330,000 cubic metres of soil and deposited it in the burial trench.

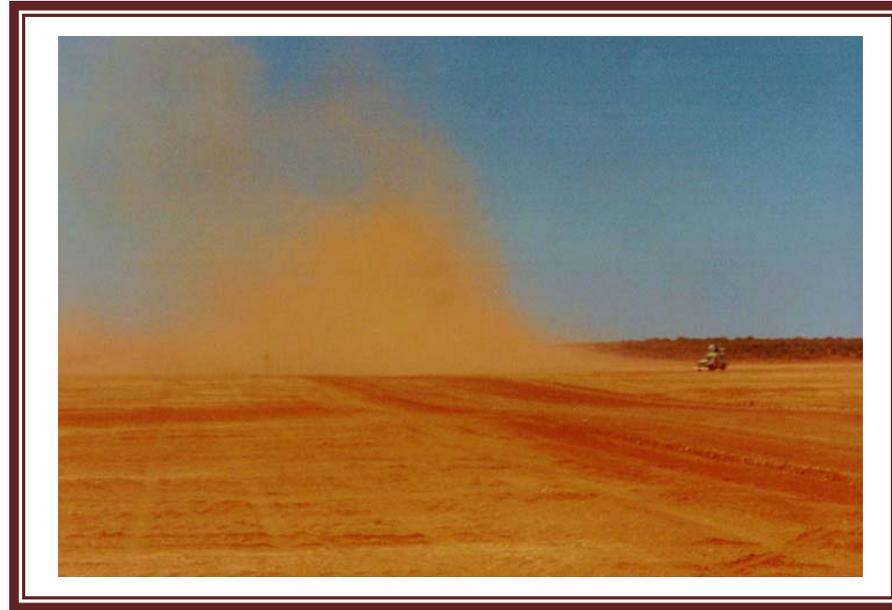
On 15 occasions, work had to stop because it was not safe to move heavy equipment in such poor visibility. On at least one occasion the Health Physics team evacuated the forward area facilities because of the dust.

One disappointing aspect of soil removal at Taranaki was the poor suppression of dust.

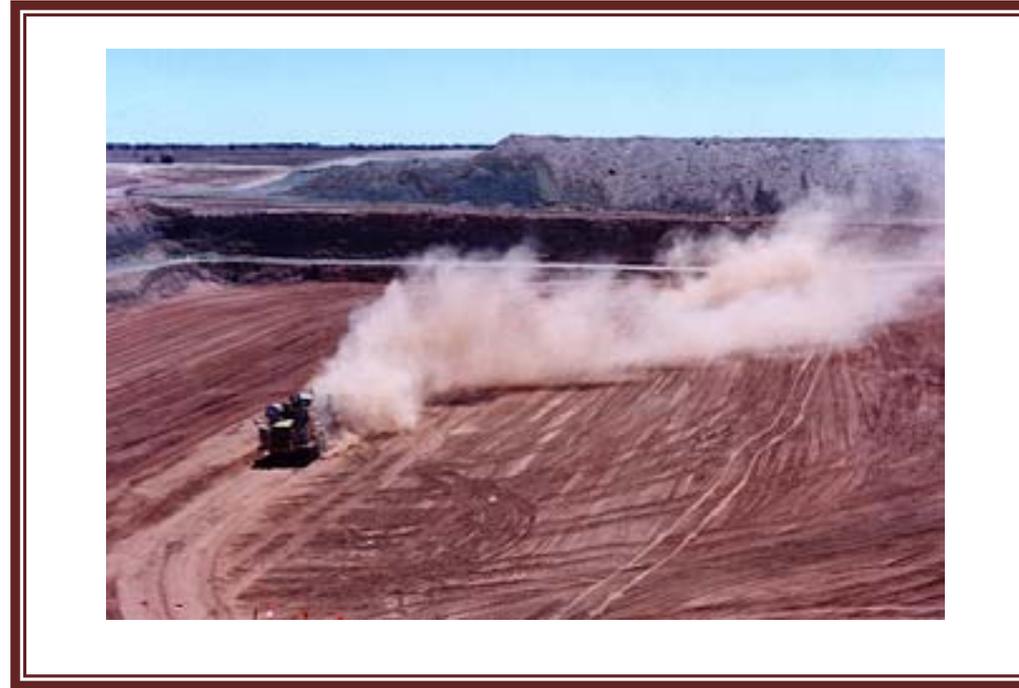
The trench was filled to about 3m from the lip. It was then covered with about 6m of clean soil.

The collected soil was transferred to the burial trench.

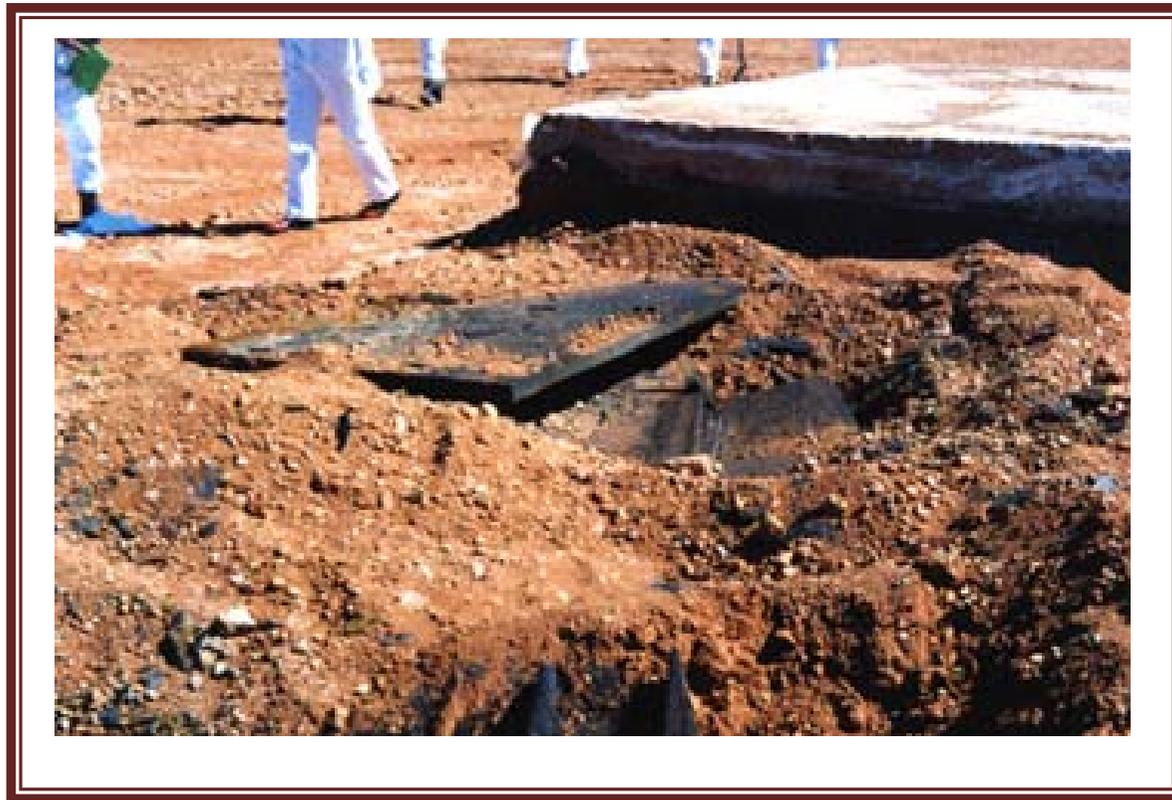
As soil was removed from Central Taranaki, the team uncovered thousands of tonnes of debris contaminated with plutonium beyond what had been reported as the pit boundaries. None of the concrete caps covered the entire pit. Two caps were several metres from the pit.

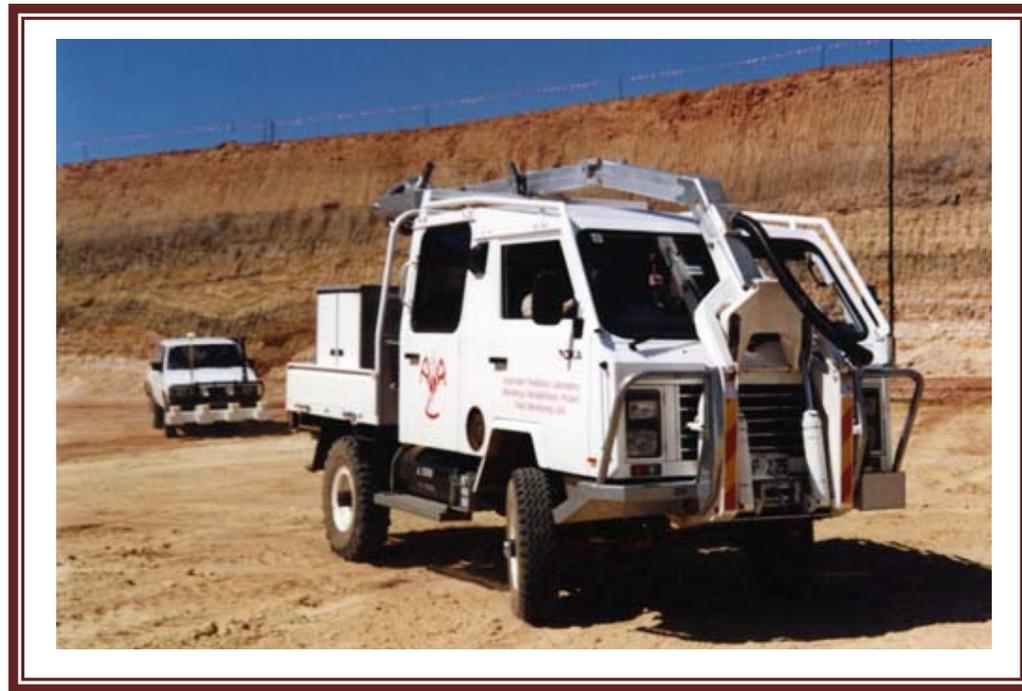
The two methods of monitoring the soil adopted by ARL

After soil was removed, the surface was monitored to confirm the criterion had been satisfied. The Contractor achieved a remarkable three thousand-fold decrease in the level of contamination.

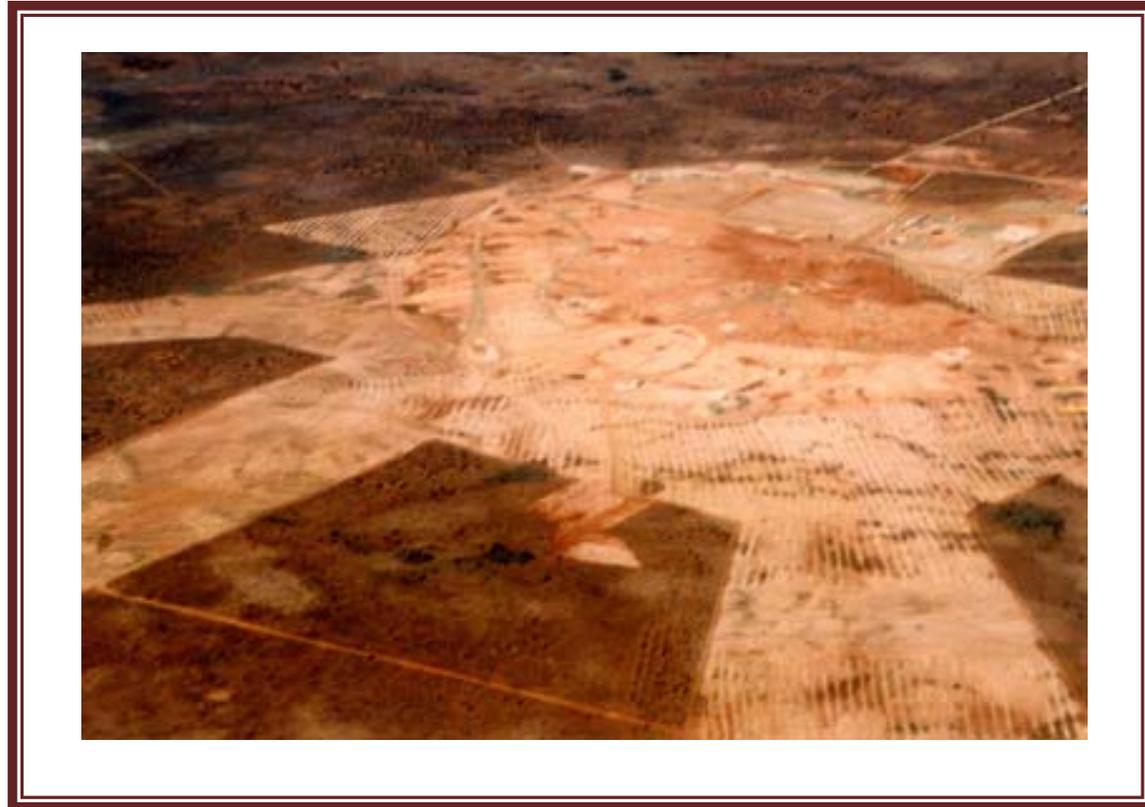
Mounds of clean soil at Taranaki

Mounds of clean soil were then placed over the scraped area and seed of native shrubs cast over the mounds to assist in revegetation.

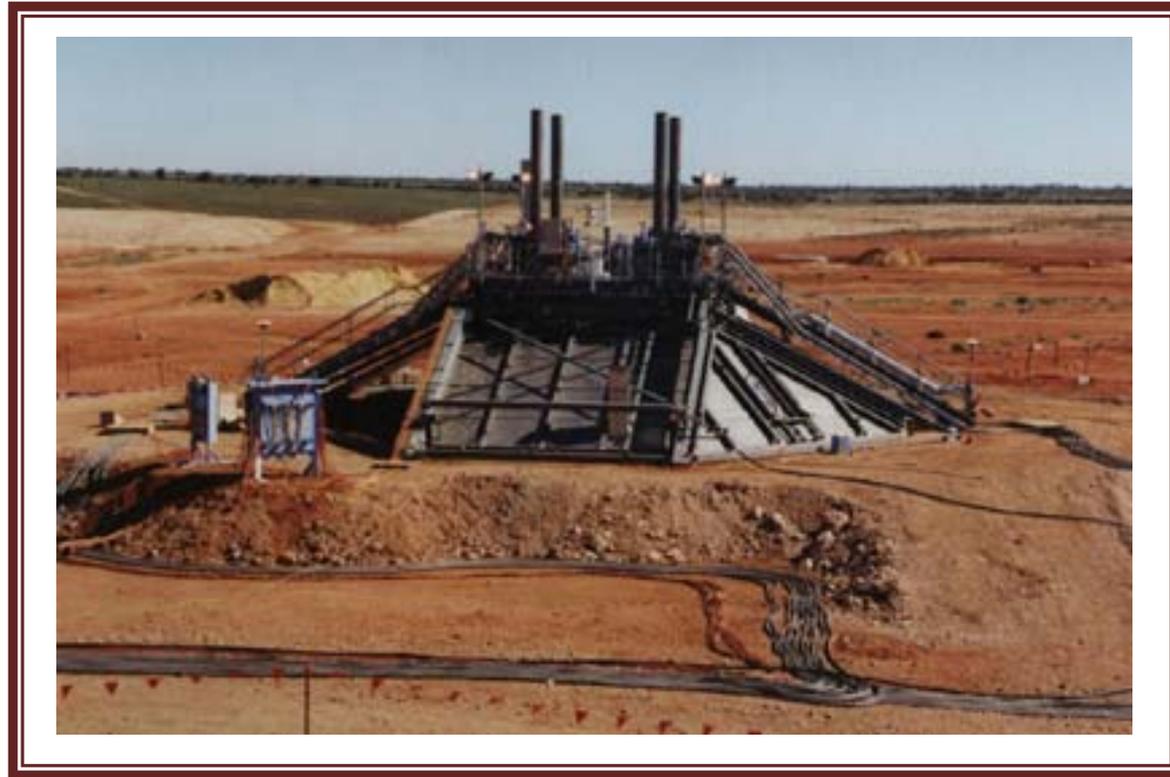
A steel hood was placed over the pit and electricity fed to the four electrodes shown protruding from the hood.

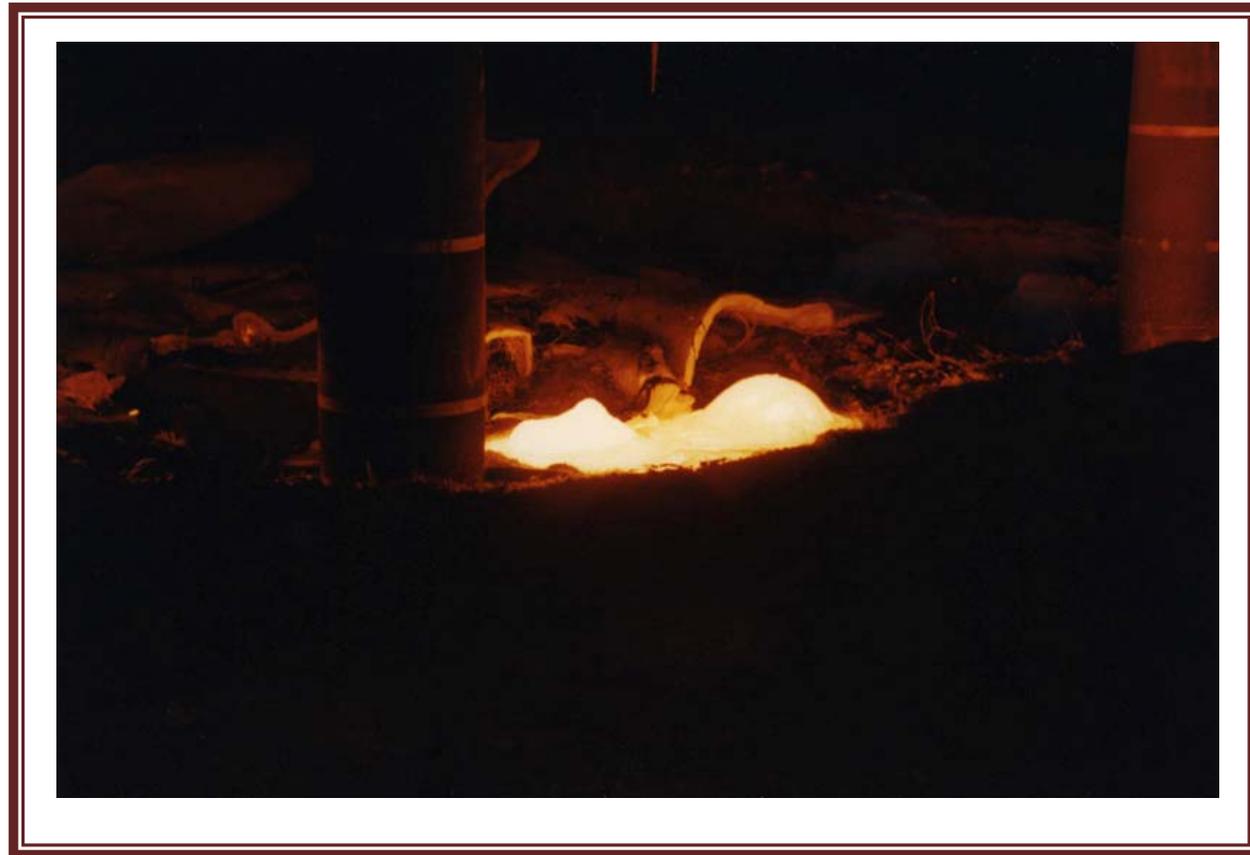
The electricity melted the silica sand that had been placed over the pit. The upper layer melted the next layers down into the pit and continued 24 hours a day for about a week until the whole pit was consumed.

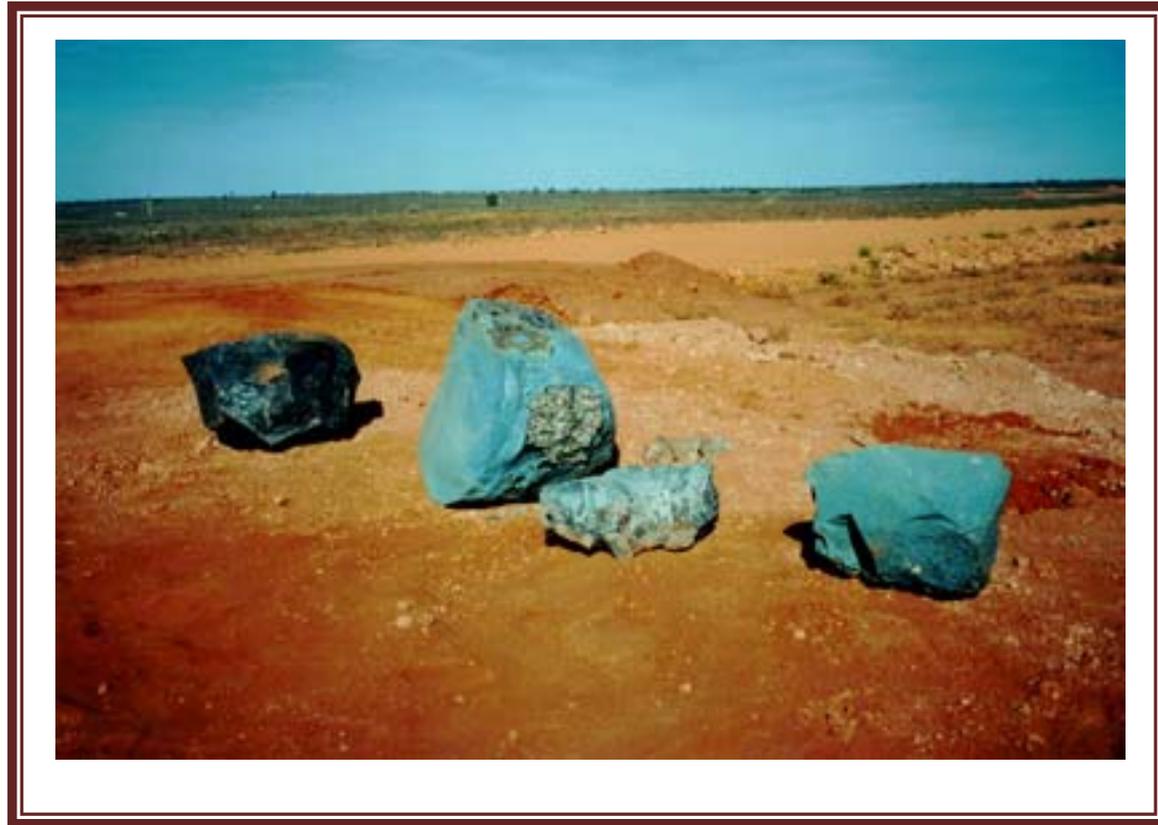
Samples of vitrified radioactive waste at Taranaki.

The pit contents were thus turned into a hard glass-like rock with properties similar to obsidian glass. This would immobilise the plutonium for thousands of years.
