# CAPE LEEUWIN LIGHTHOUSE – A GUIDING LIGHT IN THE WEST FOR EAST COAST SHIPPING

## ABSTRACT

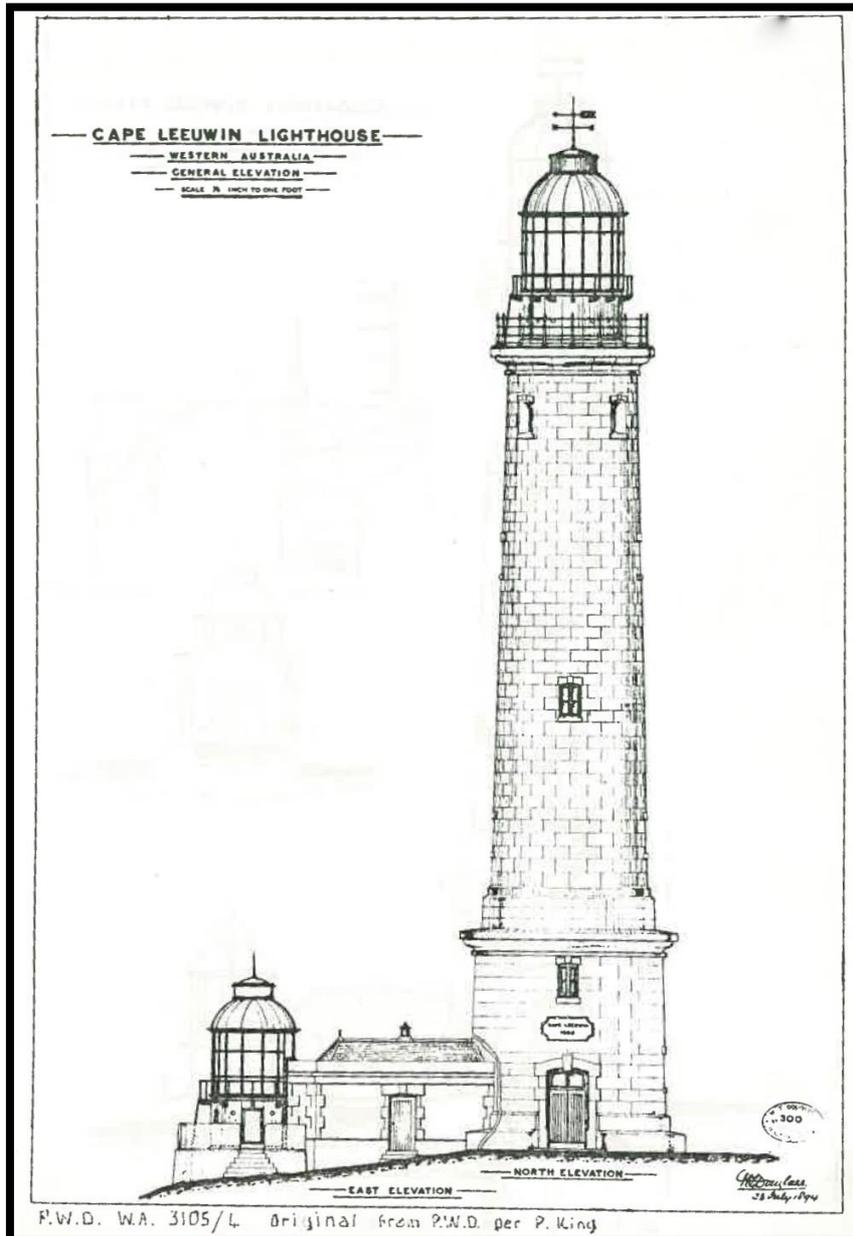
Figure 2. The original design elevation drawing, showing the additional smaller lighthouse originally planned to house a red warning light, separated from the main tower by the fuel store. The second lighthouse was never built. (The image has been taken from: Watson, p. 19)

Advice for the construction of the lighthouse was sought from the English consulting engineer, William T. Douglass. His design was received by the government in 1894. It comprised a 115 ft stone tower with a small secondary light linked to the tower by a small fuel room.<sup>21</sup> The original design drawings for the lighthouse are shown in Figures 2 and 3.

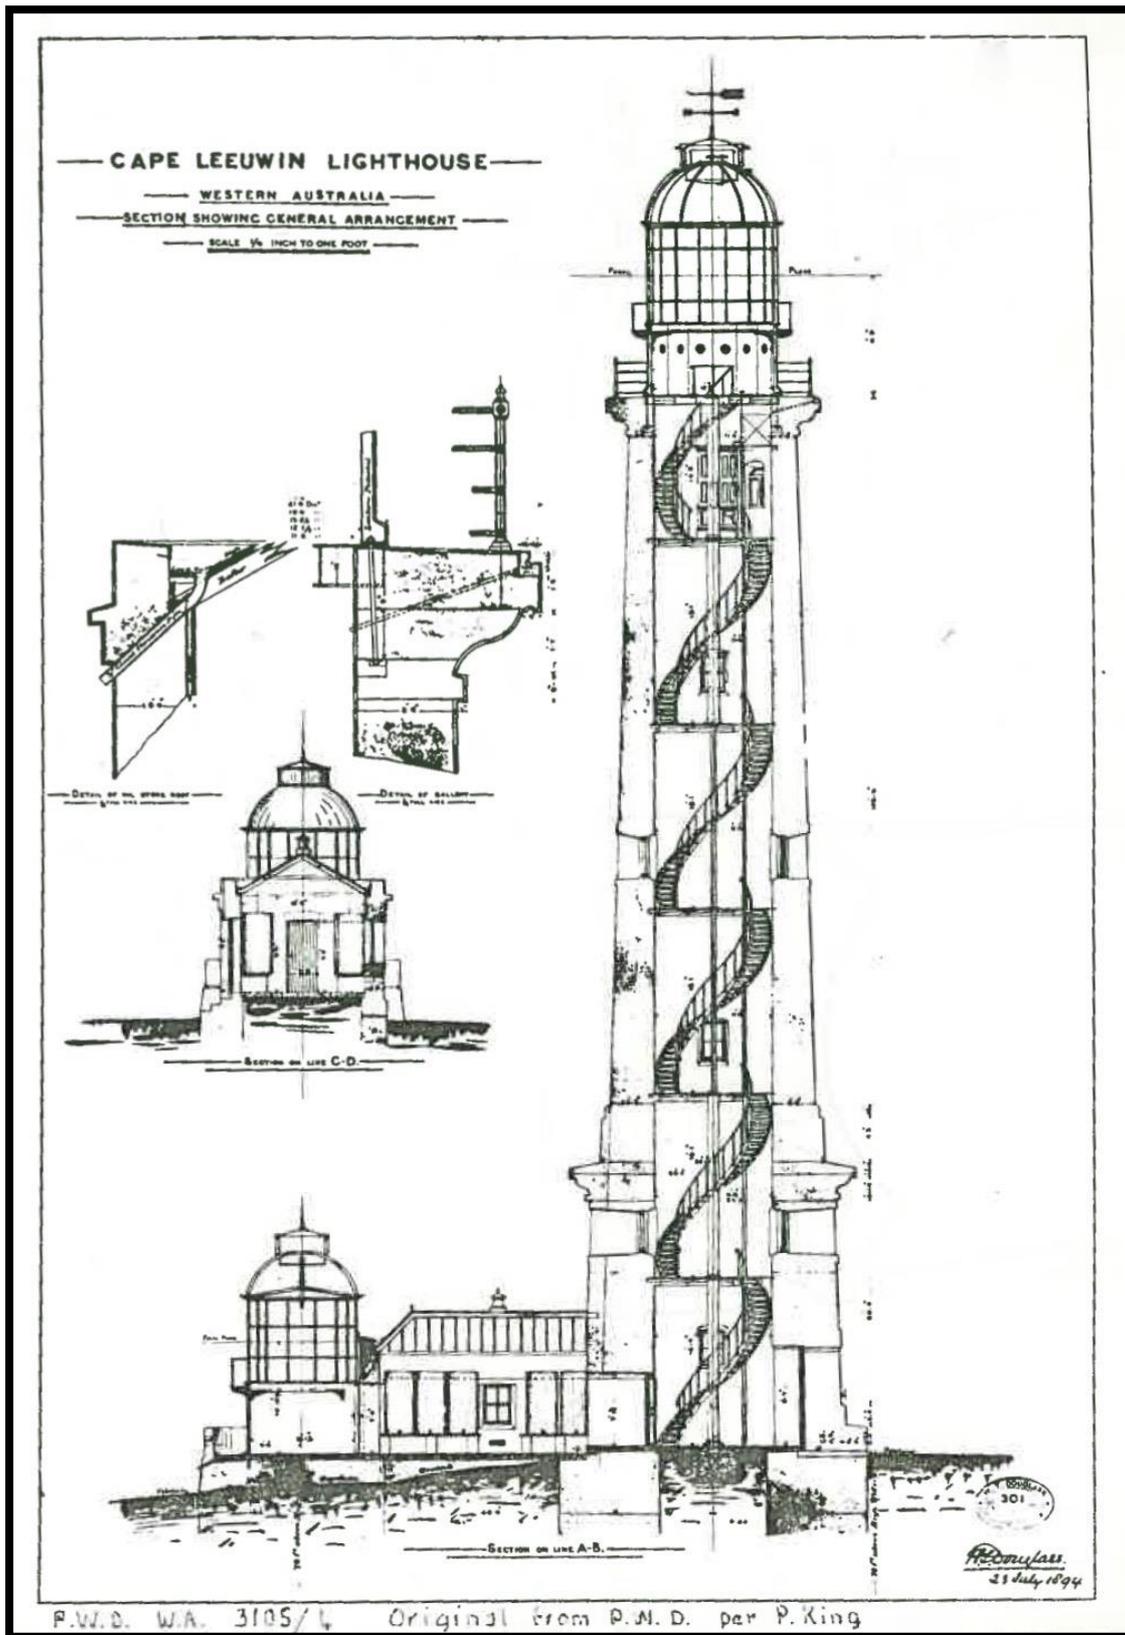
Figure 3. The original design section drawing showing the general arrangement. (The image has been taken from: Watson, p. 20)

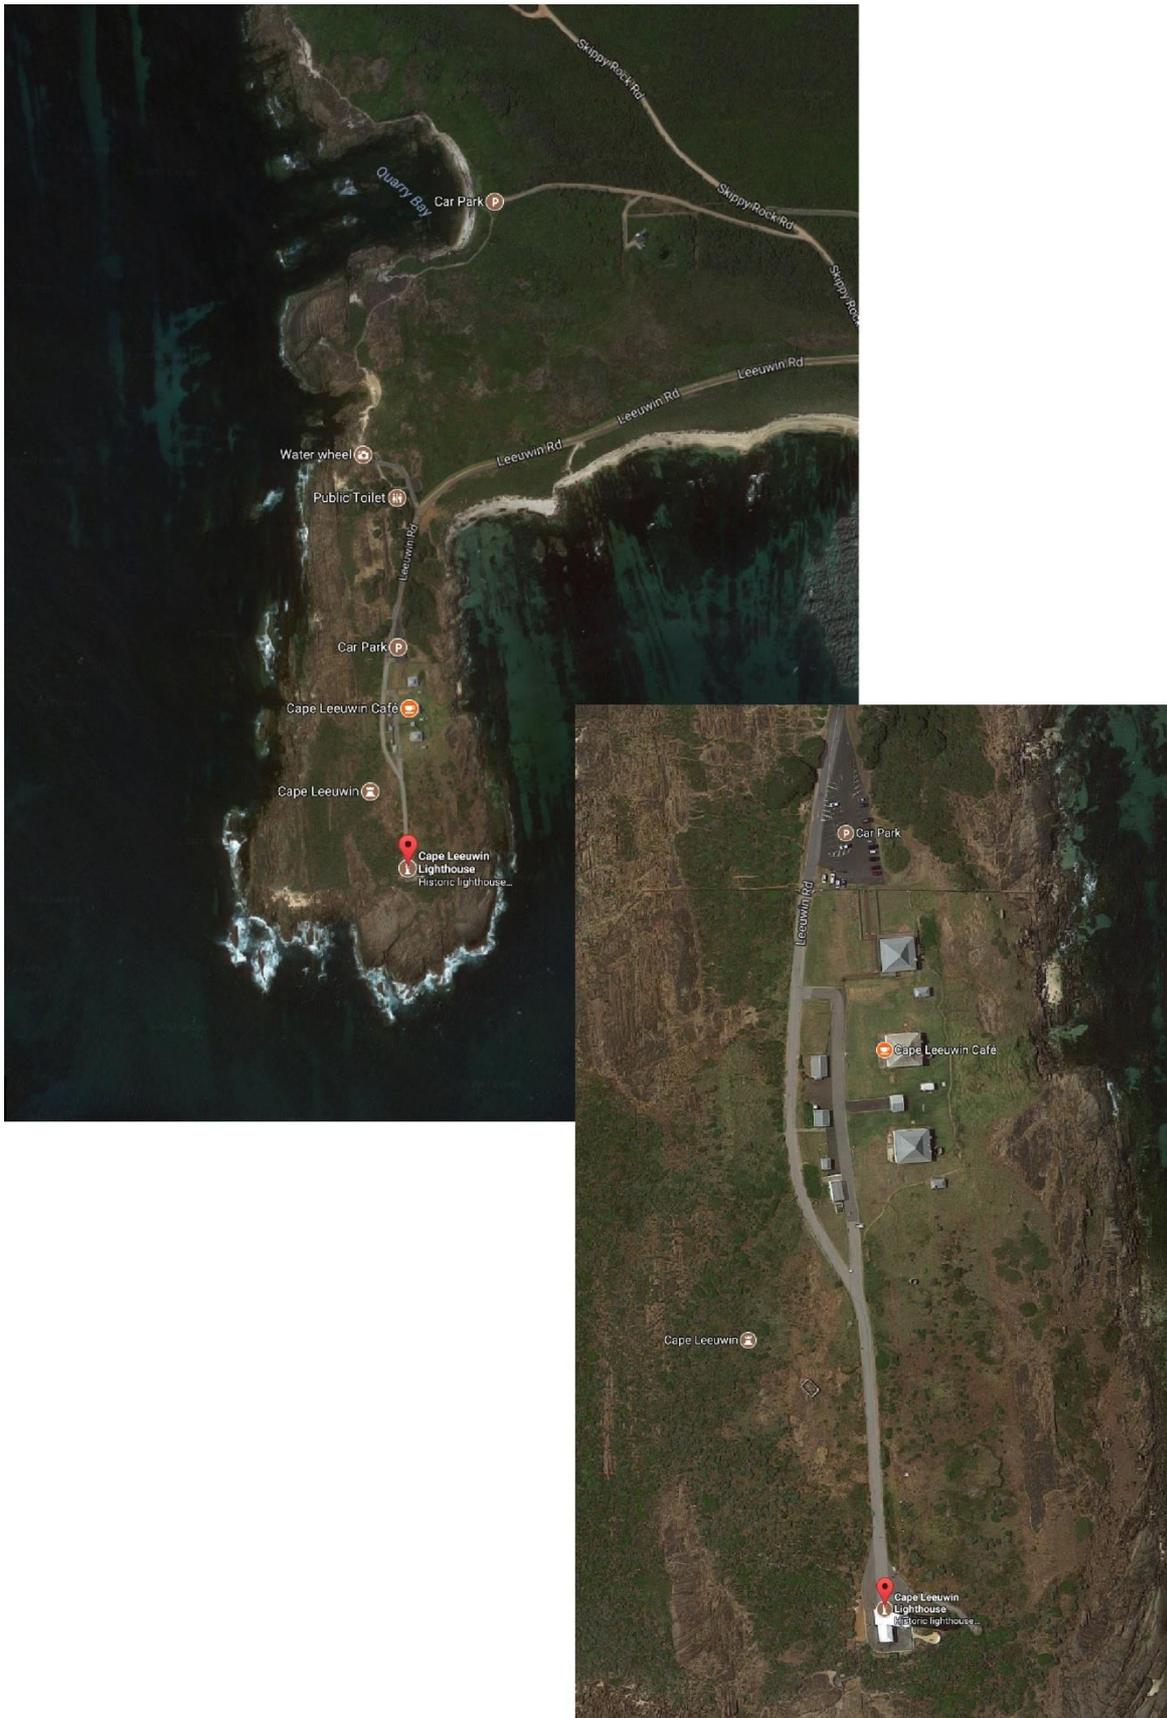
Figure 4. The precinct as it exists today. Image courtesy Google Maps, 2017

Figure 4 shows the lighthouse precinct as it exists today. Figure 5 highlights the remote location of the lighthouse, sitting on the boundary between two great oceans. The lighthouse tower is shown in Figure 6. Figure 7 shows the precinct as viewed from the observation deck on the lighthouse.

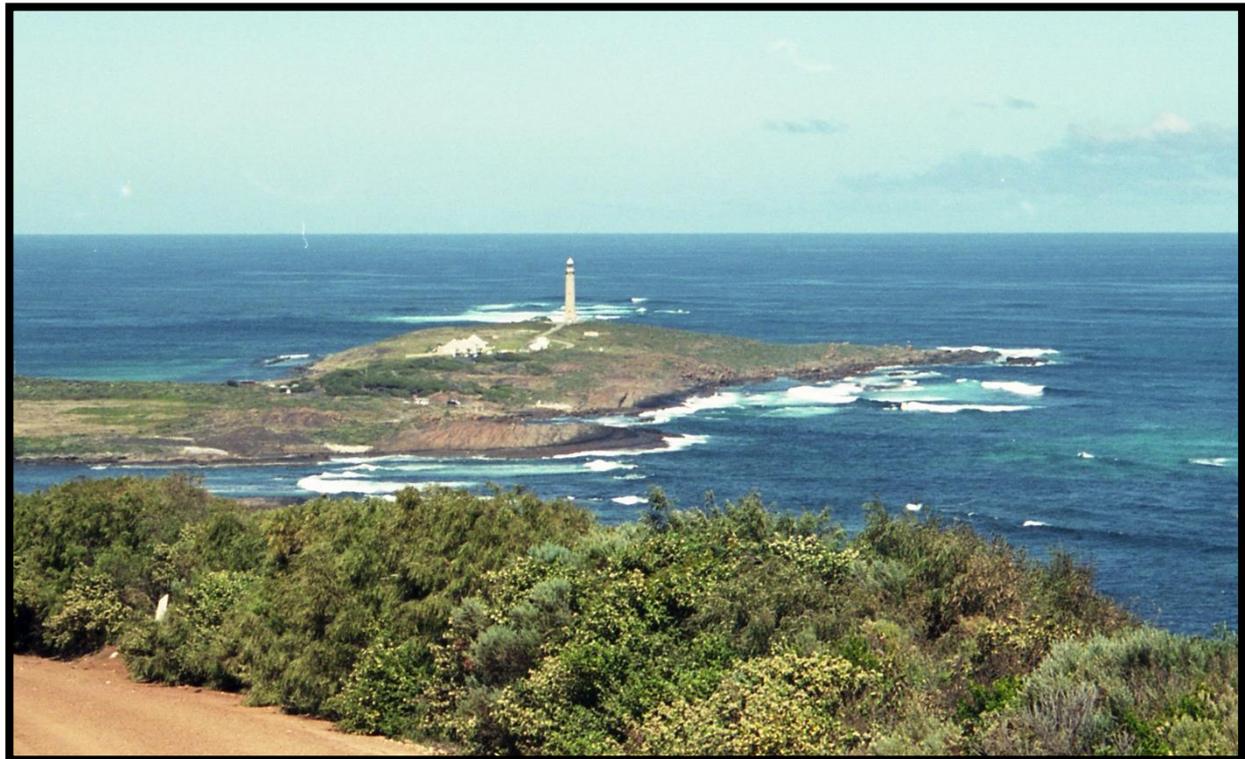
Figure 5. The remote Cape Leeuwin and its lighthouse, marking the boundary between the Southern Ocean (left and distance) and the Indian Ocean (right). The waterwheel and pump are located at the small inlet visible in the foreground below the Keepers cottages. The larger bay in the foreground is Quarry Bay.

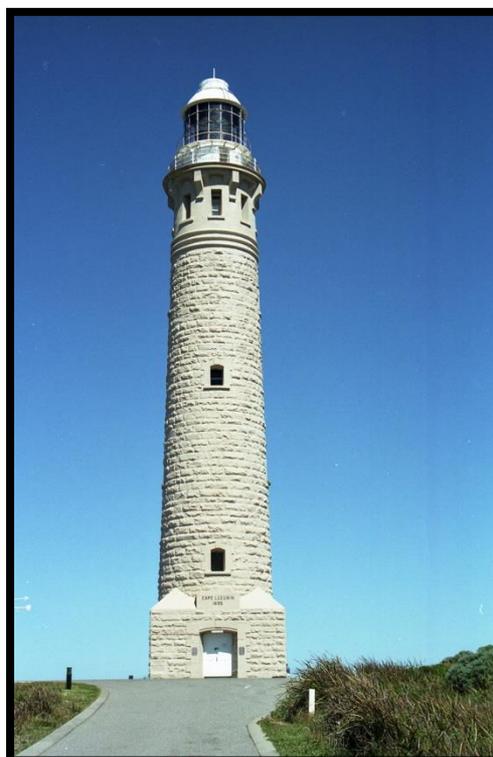
Figure 6. The Cape Leeuwin Lighthouse tower

The lighthouse has two parts, the 39 metre tall circular stone tower (foundation to light), which sits on a squared base, and a single storey room, which once served as the oil store, on the southern side. The stone work is undressed limestone with dressed stone to all openings and corners. The main entry is on the northern side through a pair of timber doors (Fig. 6). Windows are alternately spaced around the tower, with a row of windows beneath the parapet. Some of the windows have fixed panes in metal frames, while others have been replaced with glass blocks. Above the parapet is the lantern that opens out onto a circular balcony with an iron floor. An iron balustrade runs around the outer edge of the walkway. An aluminium mesh has been installed around the balustrade. The roof of the lantern dome is covered with copper sheeting. The interior of the tower features a circular iron staircase with ornamental balustrading. Through the centre of the staircase runs the metal casing that holds the clockwork mechanism. The original Chance Brothers dioptric lens remains in place in the lantern room, which has a cast iron floor. The door leading out onto the balcony is cast iron.

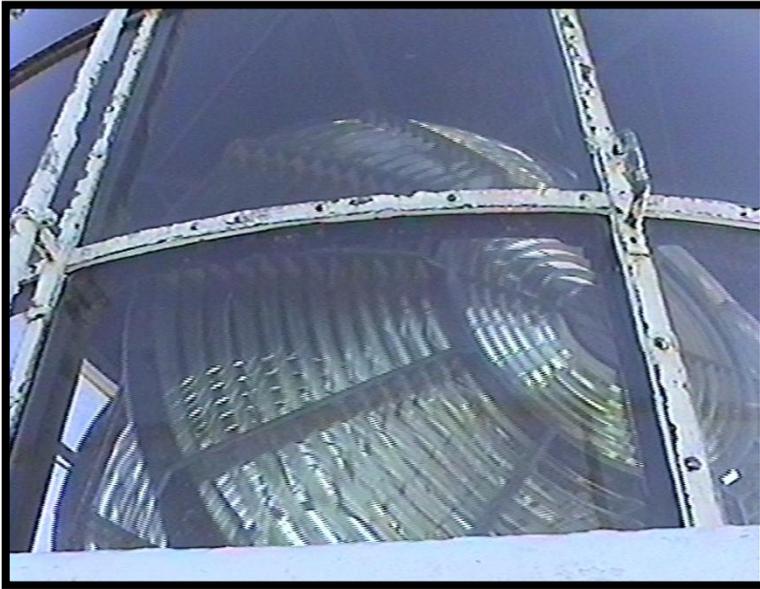
Figure 8.

The unusually large Chance Brothers optical system is still in service today.

The Chance Brothers' design for the optical apparatus specified a large lens consisting of a small number of large optical panels, which needed a powerful burner and that the apparatus should rotate at high speed.<sup>31</sup> Up until this time lighthouse optical apparatus was typically supported on a "chariot-wheel" system. These wheels were rollers that, even when regularly lubricated, required a powerful clockwork motor to keep the lens rotating evenly, even at a slow speed. As lenses became larger and heavier the rotation time for the light became longer. French designers developed a solution to this problem in the late 1870s when they invented a mercury bath to replace the rollers. The French called this new system 'feu écalir' or 'lightning flash'.<sup>32</sup> Chance Brothers soon adopted and adapted this type of mechanism. The Cape Leeuwin light was their first implementation of this technology.<sup>33</sup> The optical system designed by Chance Brothers is still in operation today (see Figure 8).

a bivalve optical apparatus, the first of this size and this arrangement yet made....the two panels, separated by a space of 114 inches, are mounted on a carriage made to revolve by clock work at such a manner that the flash from each lasts one-fifth of a second.... The time of revolution ten seconds. This represents double the time of the French 'feu éclair' arrangement hitherto adopted.<sup>34</sup>

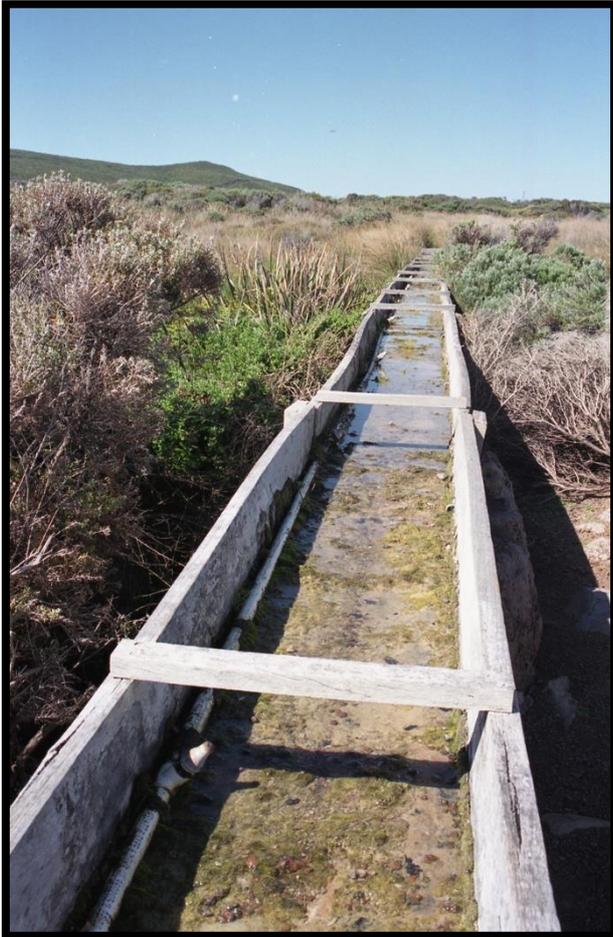
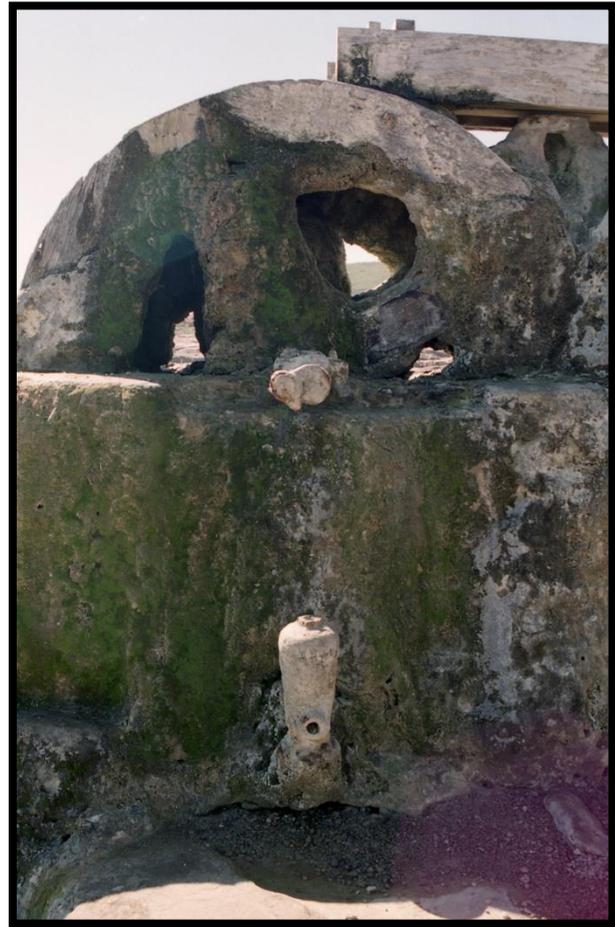
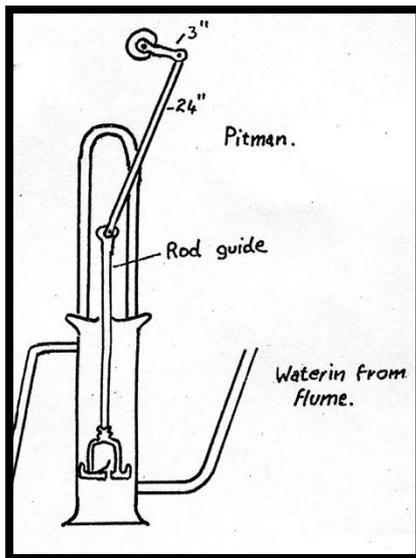
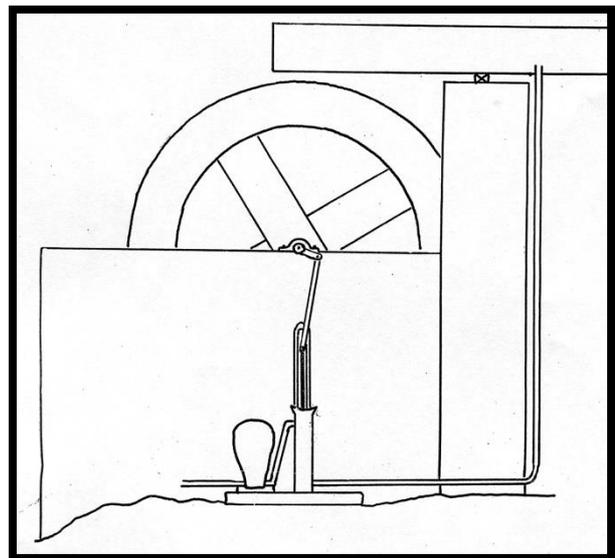
Figure 9. The wooden channel feeding water from the spring to the waterwheel (upper left) and the lime encrusted remains of the wheel and the ram pump (upper right). Sketches of the waterwheel and pump operation are shown in the lower images. (Sketches held by the State Heritage Office of Western Australia, file no. 0106.

The water wheel had also been completed and after the opening of the lighthouse, the official party visited the site for an inspection of the apparatus.<sup>42</sup> Water was drawn from a freshwater spring lying to the east, located slightly above sea level and carried via a wooden flume to the water wheel. The wheel supplied power to a hydraulic ram type positive displacement pump, which pumped water up to the lighthouse keepers' quarters approximately one kilometre away.<sup>43</sup> The current state of the flume and wheel/pump is shown in Figure 9, together with a line drawing held in the files of the State Heritage Office which shows how the wheel operated.<sup>44</sup>

The limestone coating affords the timber wheel some protection. It is considered to be in a stable condition at present. The flume appears to be a recent reconstruction, possibly dating from 1998 when the then Department of Conservation and Land Management (CALM) carried out work to allow water to flow over the wheel again. The timber flume extends some 60 metres into the scrub at which point it is replaced by a fibreglass trough. It is not known how far this trough extends into the scrub.

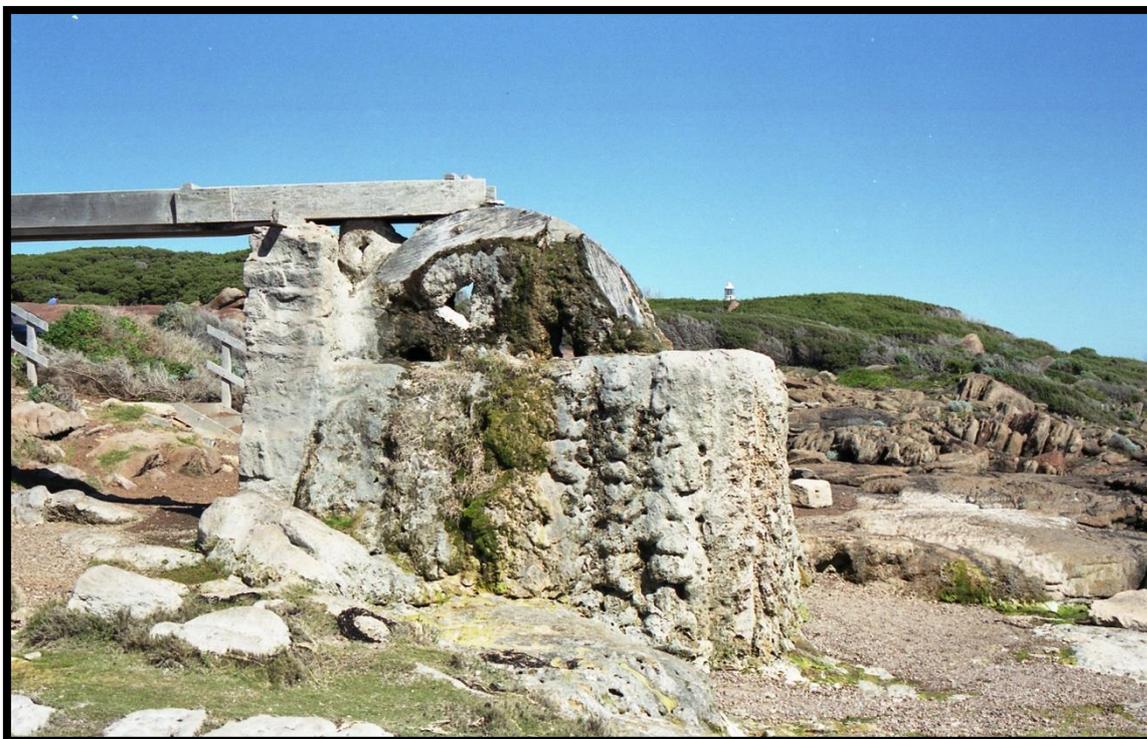
Figure 10. View of the waterwheel looking to the east. The top of the lighthouse is just visible in the distance.

Figure 10 portrays another view of the wheel that highlights the distance to the lighthouse, which can be seen in the background.

The water wheel sits just above the high tide line in a small cove approximately one kilometre to the north of the Cape Leeuwin Lighthouse Quarters. This area lies within the Leeuwin – Naturaliste National Park. The lighthouse can just be seen when looking south from the water wheel. The timber flume, which carried the water to the overshot wheel, extends out eastward from the wheel and disappears in the low brush that is found throughout this area.
